WORK REPORT:

Foundation repairs and regROUT for motor and compressor unit k2701-2

Project: 1412314 Foundation repairs and regROUT for motor and compresor unit k2701-2

Work Period: 13-23 Marzo 2015

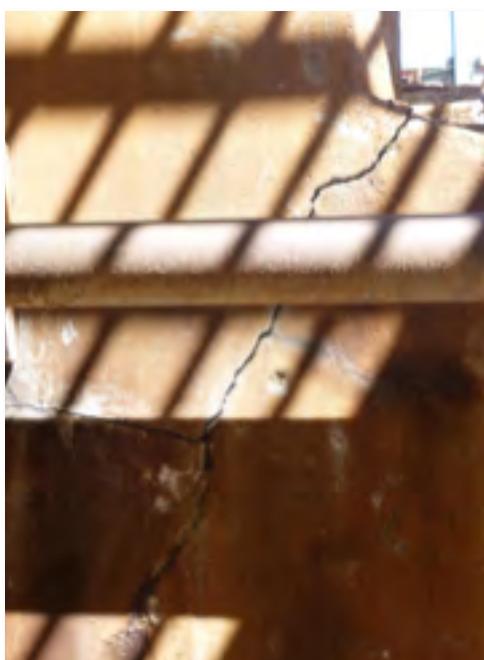
2.1. A big crack appeared, starting from the foundation step between the motor and the compressor. This crack stretches from side to side of the foundation at 225 degrees and is approximately 900 mm in length. Oil is leaking through the crack, worsening its condition and accelerating the damage process. This type of crack has developed due to cyclical forces arising from an angular misalignment between motor and compressor, whose frequency doubles the rotating speed, and because the nature of a change in section, which acts as a stress concentrator.

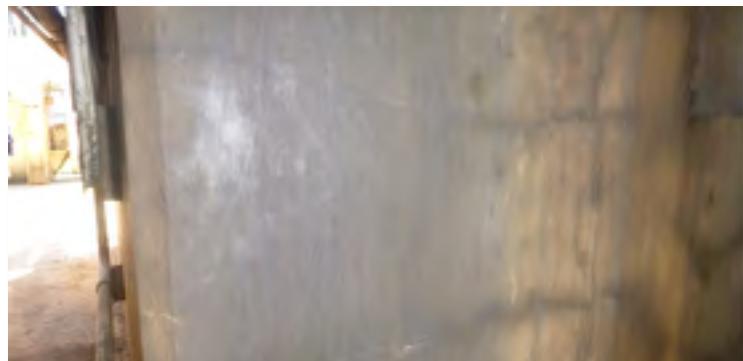
2.3. There is an obvious cold joint between the underground mat and the foundation.

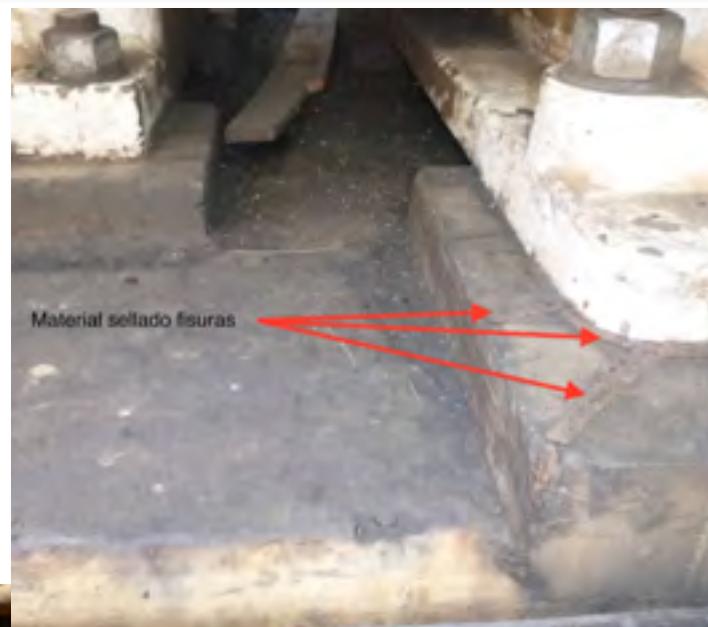
2.5. The grout health supporting the crankcase and motor is quite poor. It's a cementitious grout, and appears to be cracked in multiple places, with defective adhesion to the foundation and not installed according to the API RP 686.

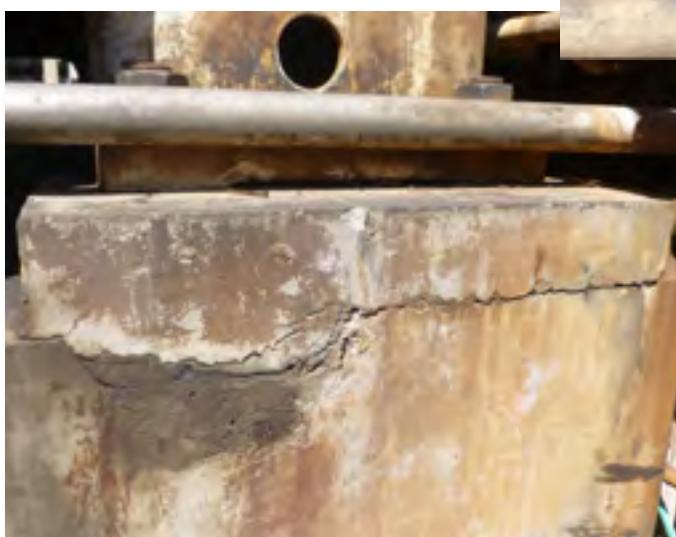
are completely corroded which could be one of the causes of the misalignment. They should be removed, machined and reinstalled properly, using proper INOX shims, rounded corners and epoxy grout.

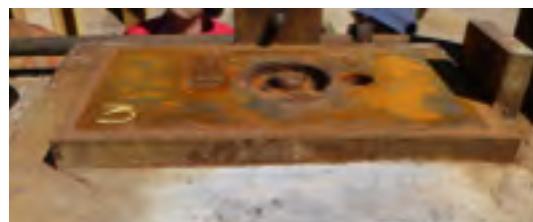
2.9. Regarding the motor, the baseplates

2.10. Anchor bolts are of steel quality 5.6 and tightened to 990N·m. We recommend higher torque, between 60-70% yield so anchor bolts should be retightened to 1,450 N·m to hold down the machine, and the best grout AT800 to uphold it in place, maintaining long lasting alignment.
