## **Work Report:**

### **Restoring the grout on the footings of the HTF Tanks.**

**Customer:** UTE Andasol 3

**Date:** February 2015

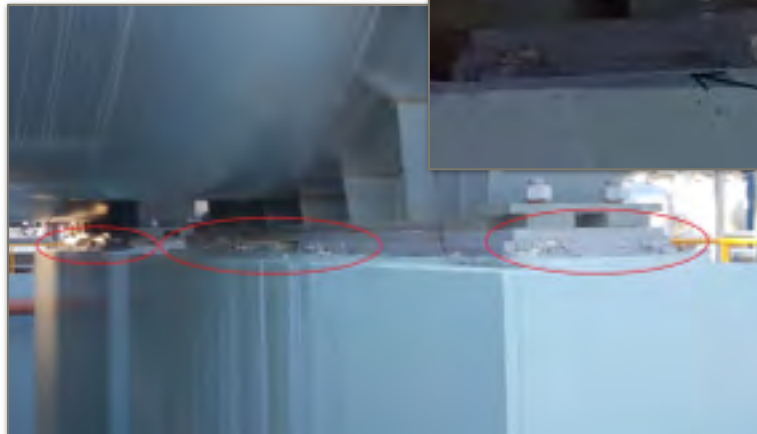
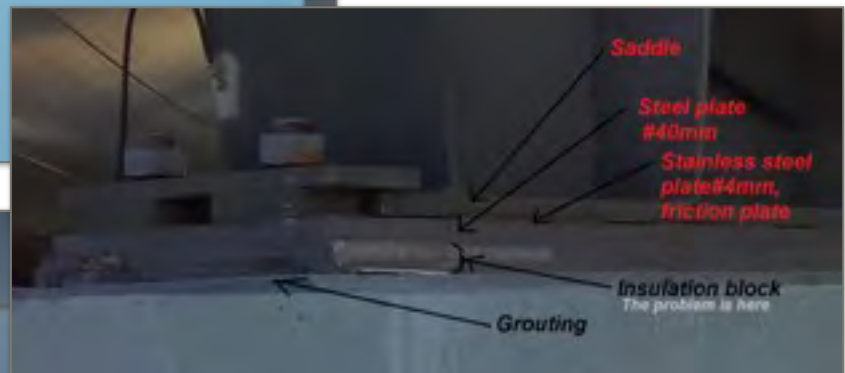
The anchoring+insulation system used for the moving supports is thoroughly deteriorated. The insulation part was designed and built using two different materials: two insulation plates and one cement grout which add up to approximately 110mm in thickness. There are also four M64 anchor bolts per footing, grade unknown, the saddle and the steelplate+friction plates.

Any good cementitious grout upholds a shear stress resistance within the adhesion surface of 1.75 MPa, supposed ideal conditions (which *slightly* differ from in as built conditions). This shear forces, together with a laminated disposition installed without any bonding agent and the loose anchor bolts, was enough to induce a progressive cracking on the isolating material.

In situ our team observed that the saddle, the steel plate and the isolation layers moved conjointly. This fact added dynamic friction to the crack party, degrading further and faster the isolating material.

The steel baseplates were installed without rounded corners and act as stress concentrators.

After 40 years working experience, we recommend the use of epoxy grouts when high shear stress, compression/tension load cycles, adherence failures and vibration problems are expected, such as in this case. Our specially developed AT800 is the best choice because of his advanced technical properties (shear stress resistance 37.9 MPa, Compressive strength 100 MPa, Flexural strength 26,1MPa)
