JOB REPORT

End User: Total E&P UK, Shetland Gas Plant

Project: Skid perimeter grouting, skid fill, and pressure injection

Dates: 3 May to 7 June 2016

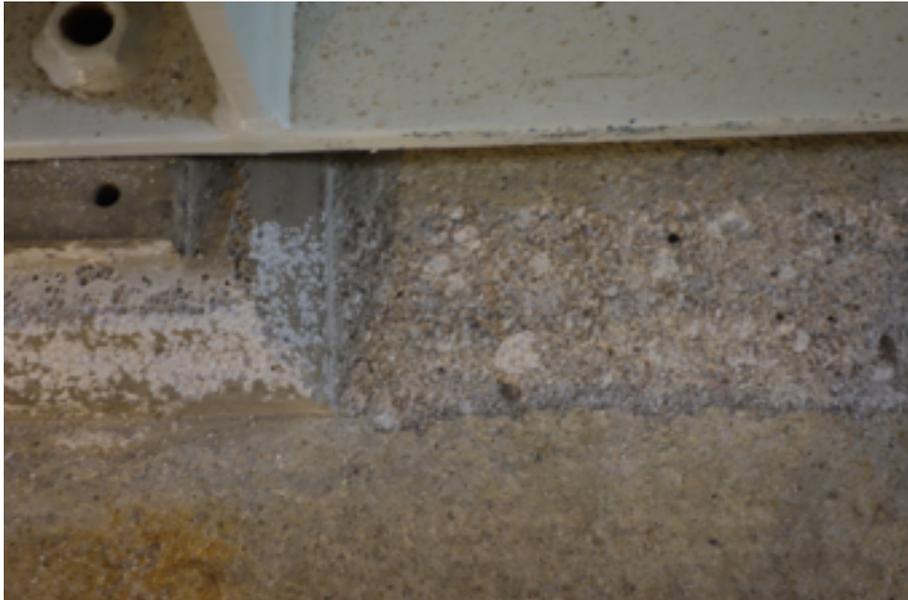
- 2.2 We were eventually able to mobilize on 3 May, and site work started immediately on scabbling the concrete surface outside the skid perimeter. The concrete under the skid had been hp water washed, by the on-site contractor, but drying time was excessive, and the Method Statement was changed to air blowing for subsequent skids.

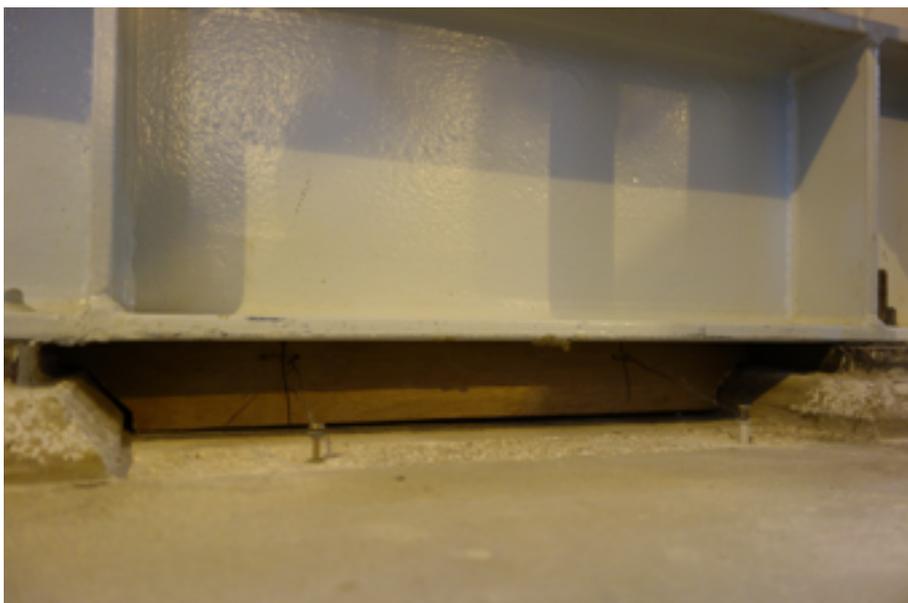
- 2.3 Inner forms were prepared to contain the epoxy grout. This phase was also adjusted to allow for drilling of the top plate to be completed before work on the concrete.

The inner forms were cut to size, using a pneumatic jigsaw, and supported against the back of the original grout pads by wire secured to small concrete anchors. Gaps top and bottom were then sealed with epoxy putty.

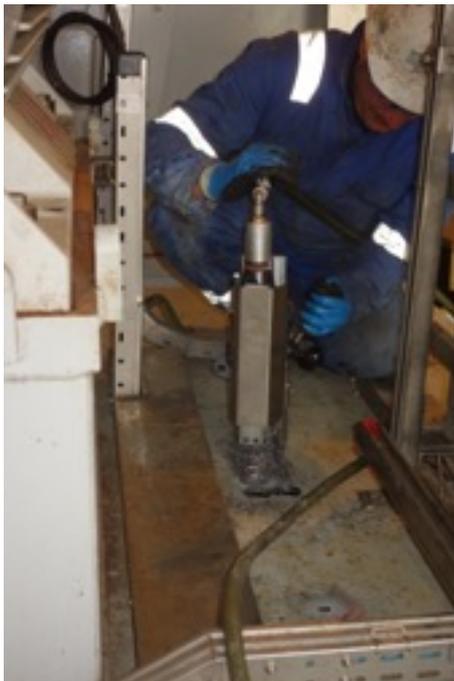
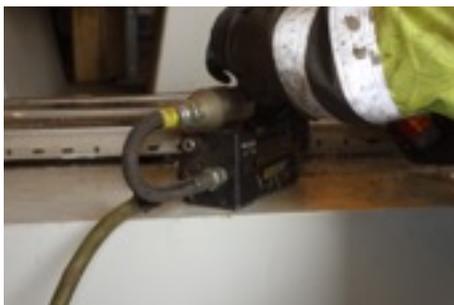
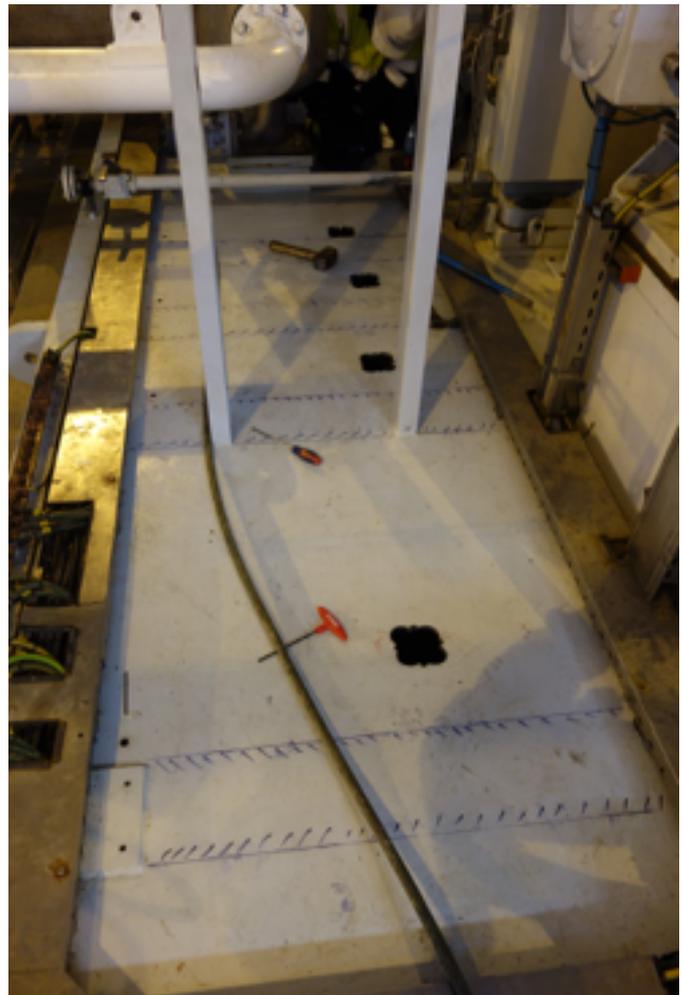
- 2.4 Heavy duty plywood forms were then fabricated, and covered with PE release film, and set in place 100 mm from the skid edge.
- 2.5 ALPHATEC 800 epoxy grout was mixed and poured to embed the lower flange of the skid, and allowed to cure overnight.
- 2.6 Cement grout injection holes were cut in the top plate of the skid, using pneumatic magnetic-base drills. 15 mm diameter breather holes were also drilled in the high side of each compartment.

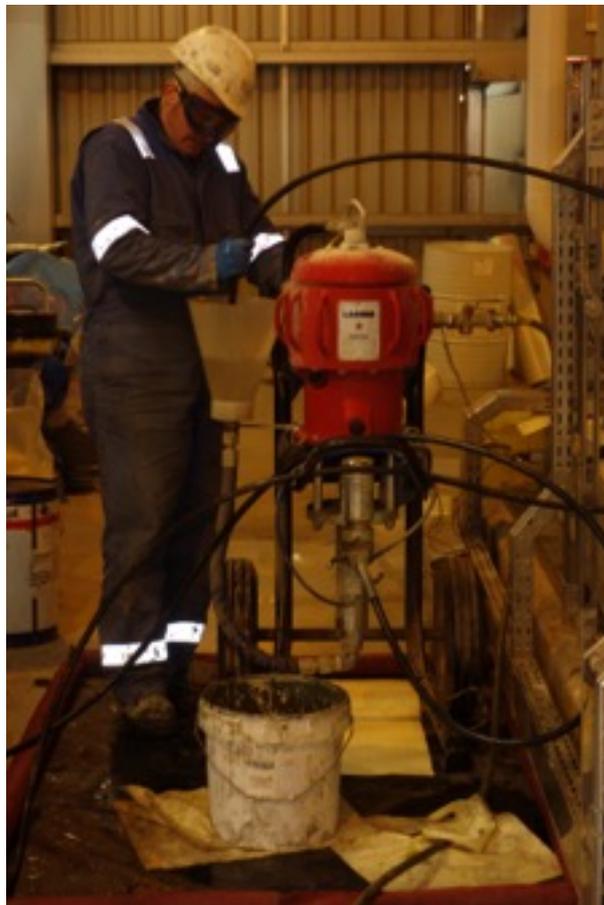
- 2.8 After the cement grout had cured overnight, holes were drilled through the grout in 5 places, to a depth of approximately 650, and 600 mm lengths of reinforcing bar placed into the holes with copper tubing attached.
- 2.9 The top of each hole, and the top of each cement injection hole was sealed with ALPHATEC 800 epoxy grout, which cured well overnight, thanks to the remaining heat of hydration in the cement grout.
- 2.10 Breather holes were tapped to allow installation of 3/8" NPT grease nipples.
- 2.11 ALPHATEC 342 liquid grout was mixed and pumped into each each injection point in turn, using a Larius Nova 60:1 pneumatic plunger pump, and pressures of up to 400 bar, to ensure good bonding between the cement grout and the foundation, and between grout and skid.

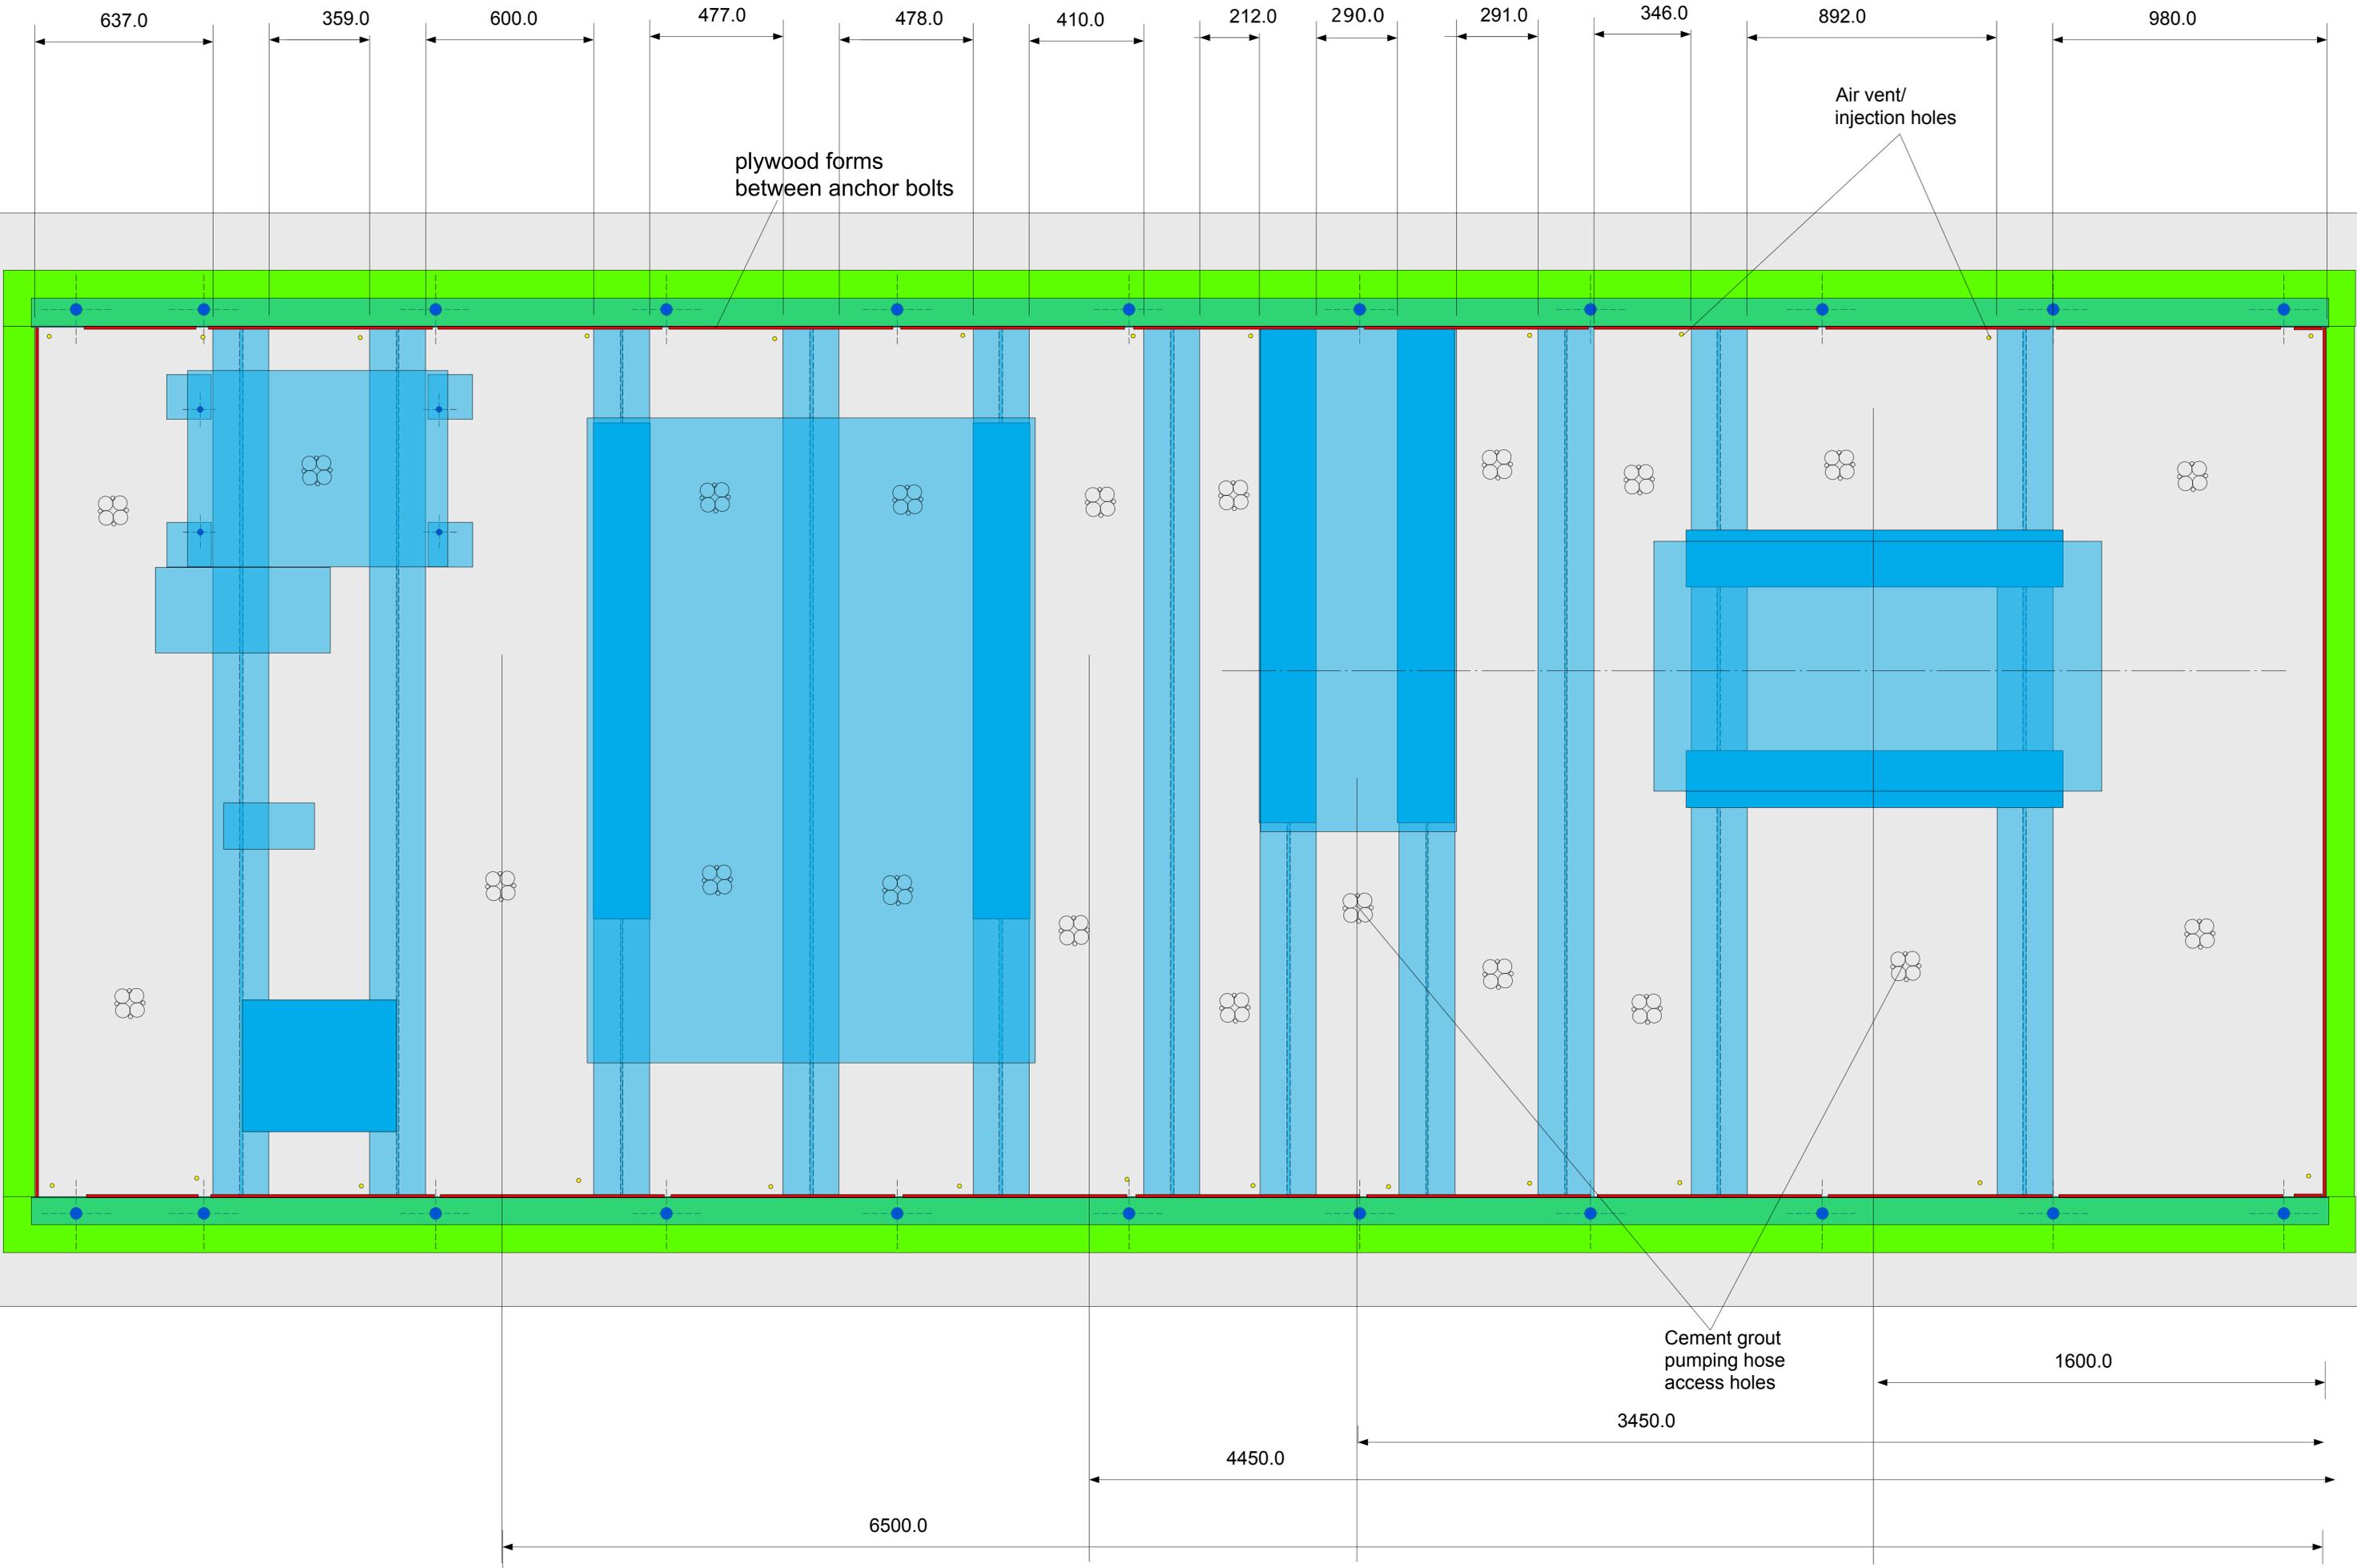
plywood forms
between anchor bolts

Air vent/
injection holes

Cement grout
pumping hose
access holes
