WORK REPORT:

Foundation repairs and regROUT for motor and compressor unit k2701-2

Project: 1412314 Foundation repairs and regROUT for motor and compresor unit k2701-2

Work Period: 13-23 Marzo 2015

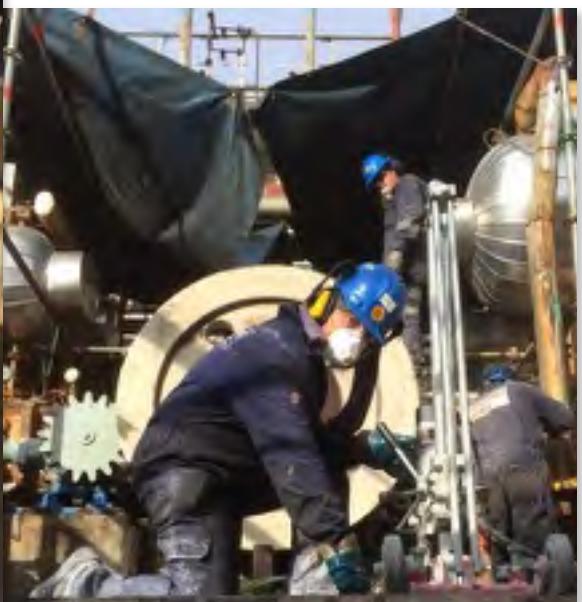
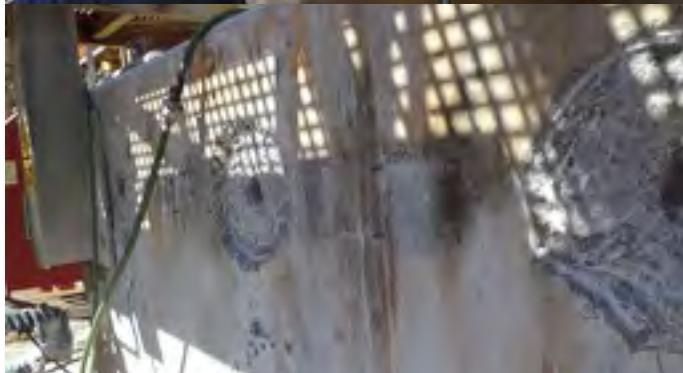
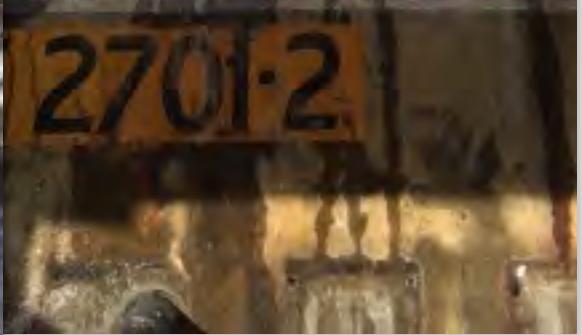
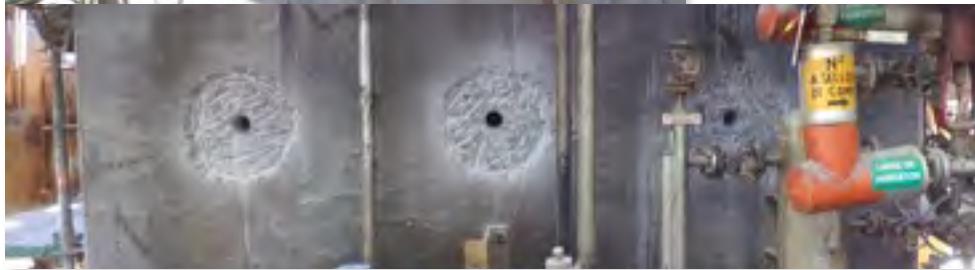
In the horizontal ones the proper surface preparation was carried out to house the steel discs (washers) and the epoxy sealing material.

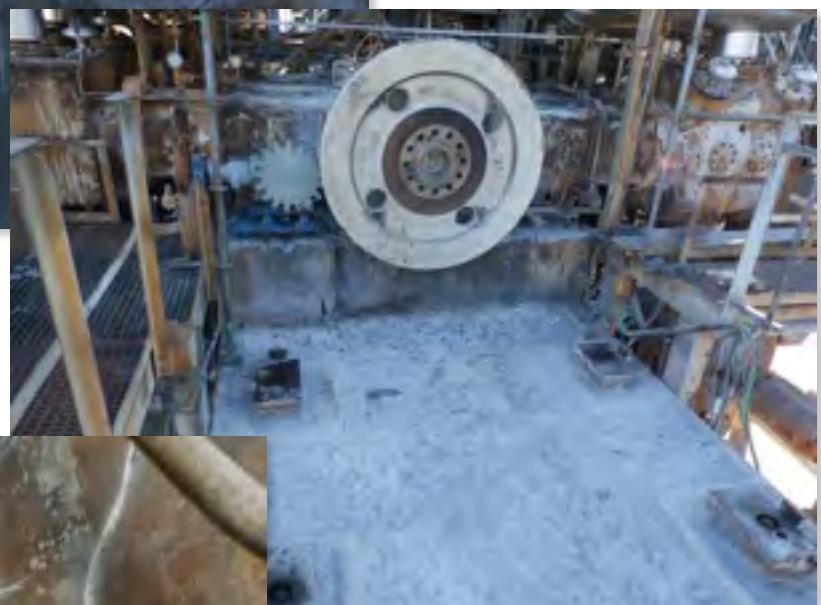
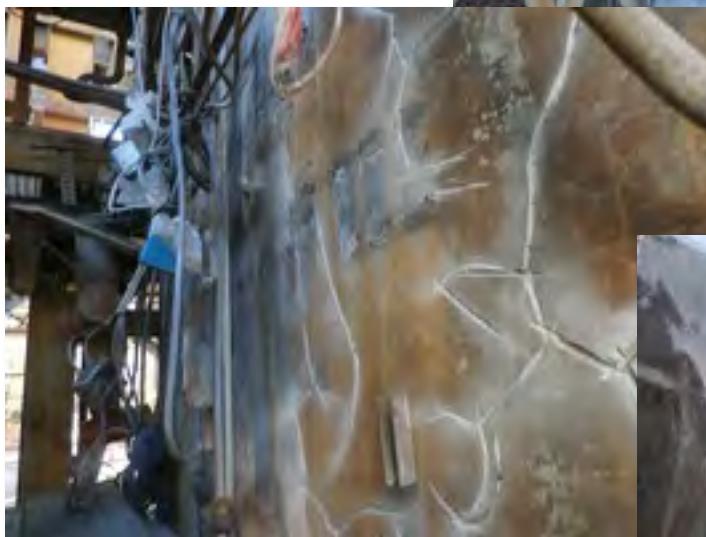
A layer of approximately 50 mm was also removed from the upper surface of the drive end of the foundation.

The side surfaces were inspected and all major cracks found were outlined and deepened, to be covered up afterwards with an Alphatec resin filled with thixotropic aggregates.

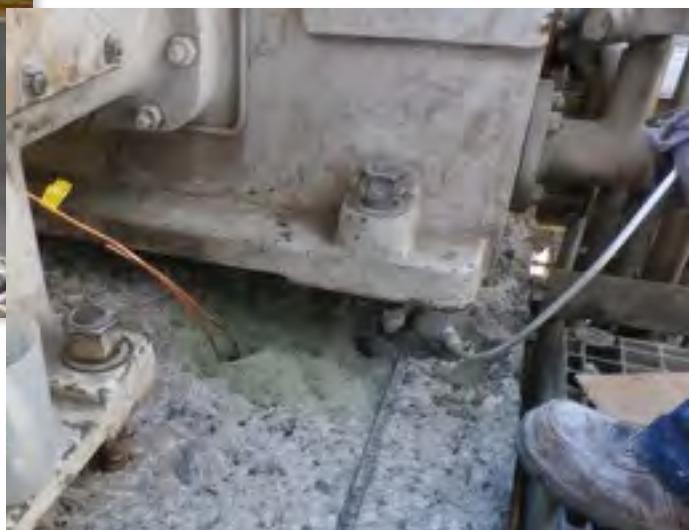
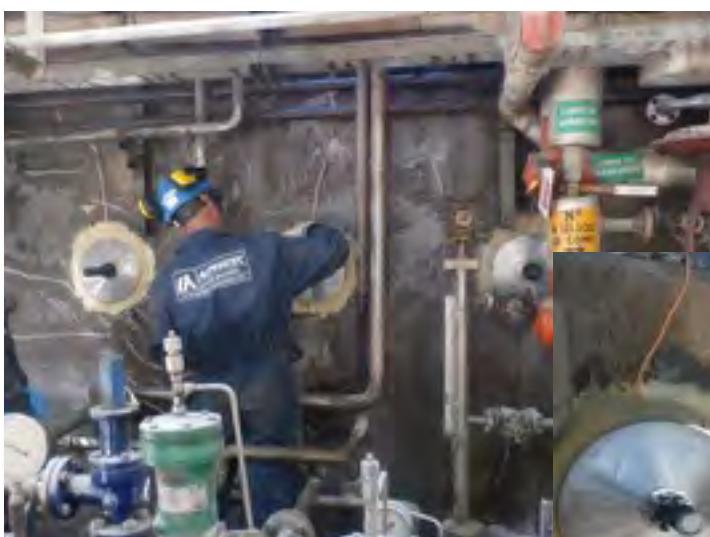
In the horizontal holes, grade10.9, fully threaded steel bars where installed along with injection and vent tubes, and sealed with the discs (washers) and the thixotropic epoxy material.

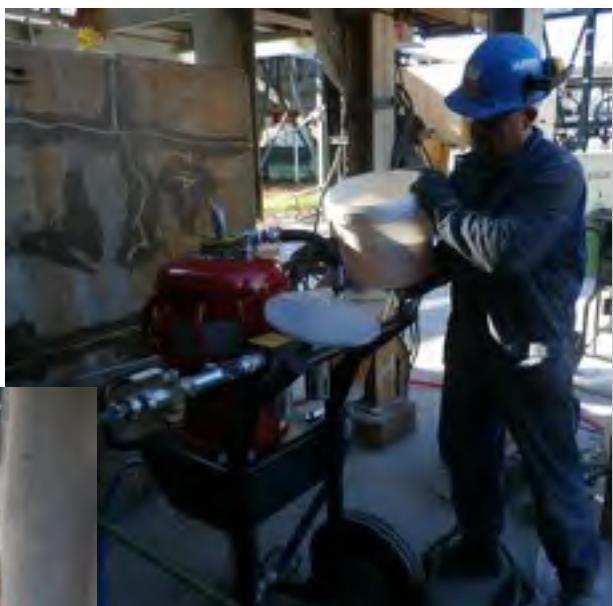
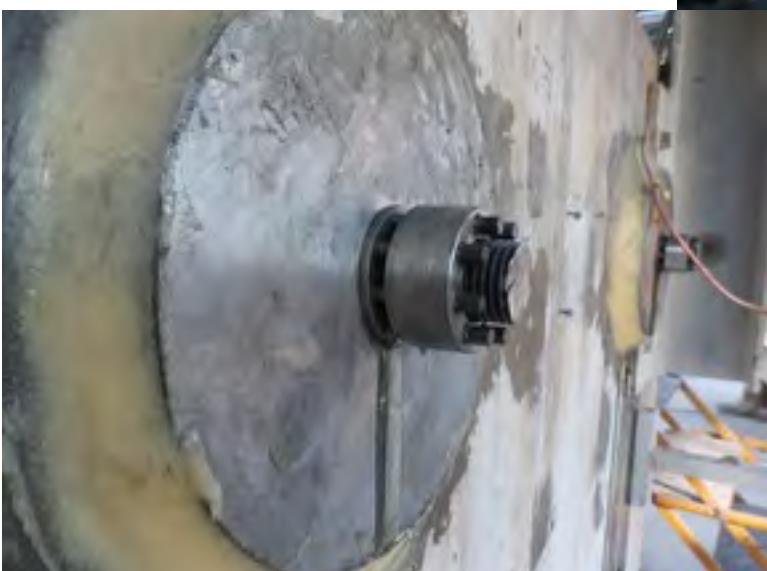
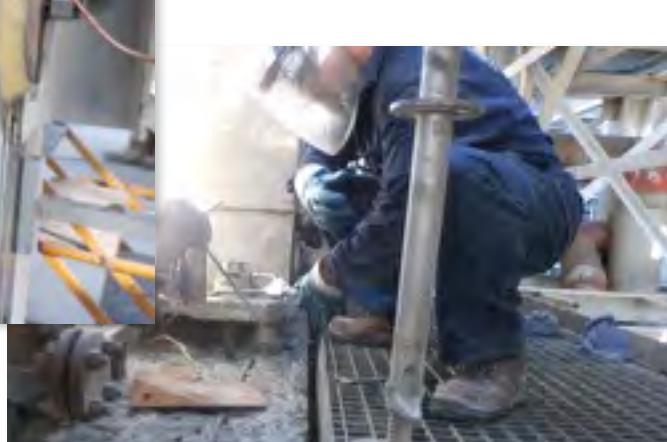
3.6. Immediately after finished injecting, we tightened the Superbolts to the calculated 70% yield, applying 90 N·m to each one of the superbolt nuts, inducing a tension higher than 360kN on each horizontal bar.

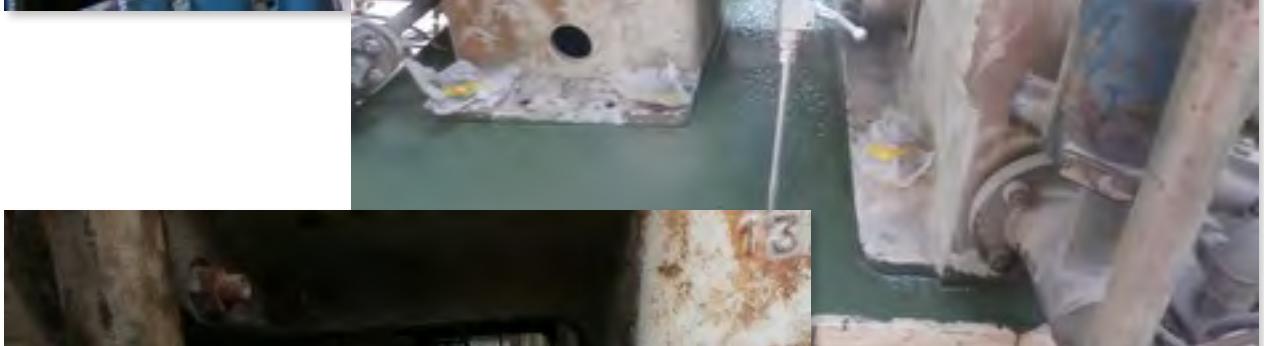
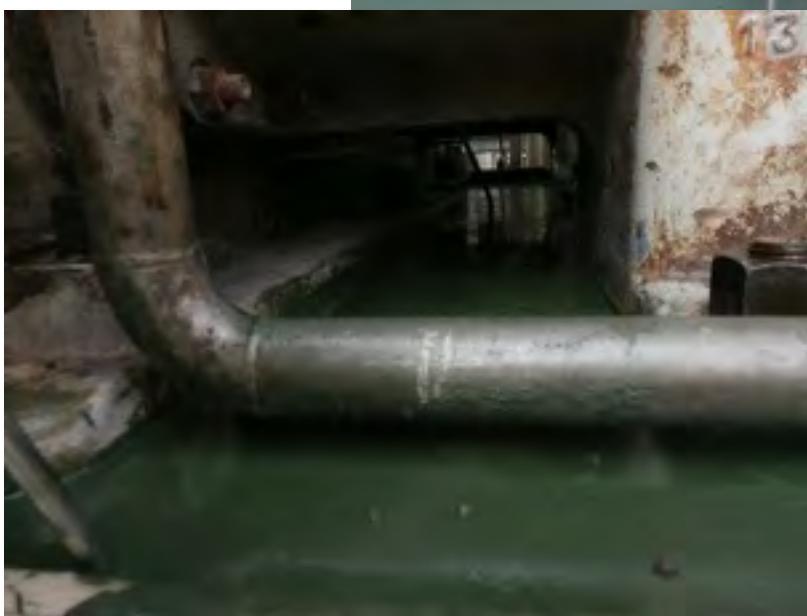
Formwork sealed, nuts and all the adjoining elements protected.

All anchor bolts were isolated from the grout using PE foam.

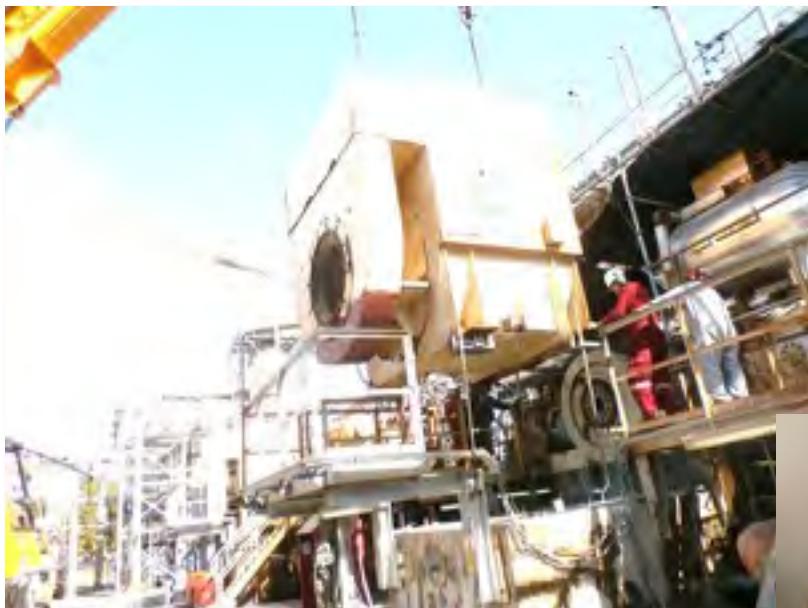
3.10. For the motor, before installation the base plates and shims had to be already machined . Before lifting it to its final position, the 2 mm. thick shims and base plates where installed and tightened on the motor.

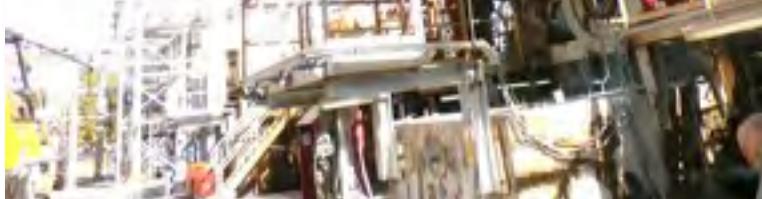
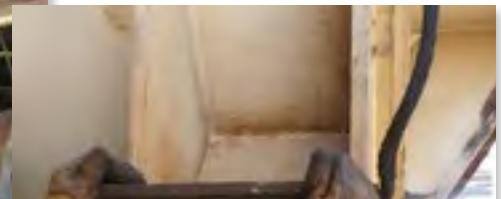
All four Alphapads where connected to a distributor to control individually or jointly the pressure for the alignment of the system.

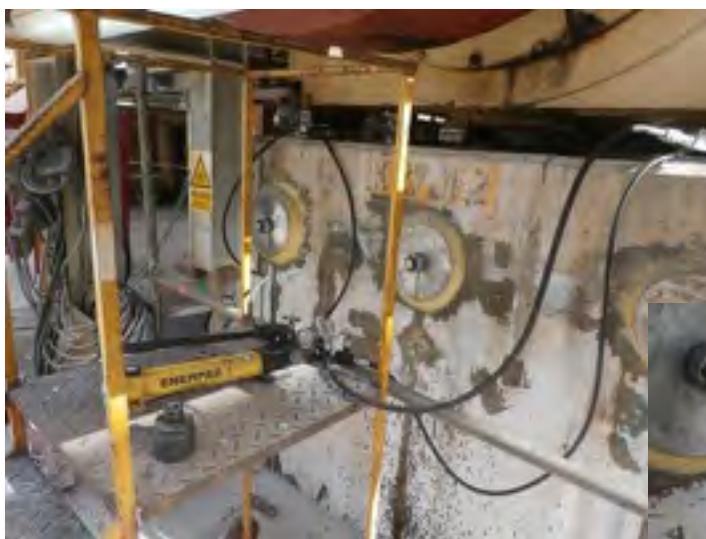
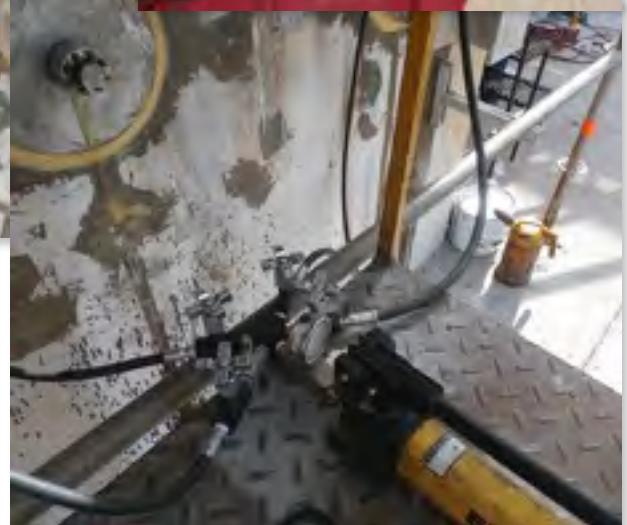
The alignment was carried out following the instructions of the specialist and the experimented workers and engineers of Shell.

The motor-compressor axis was aligned using first laser equipment for the measurements.

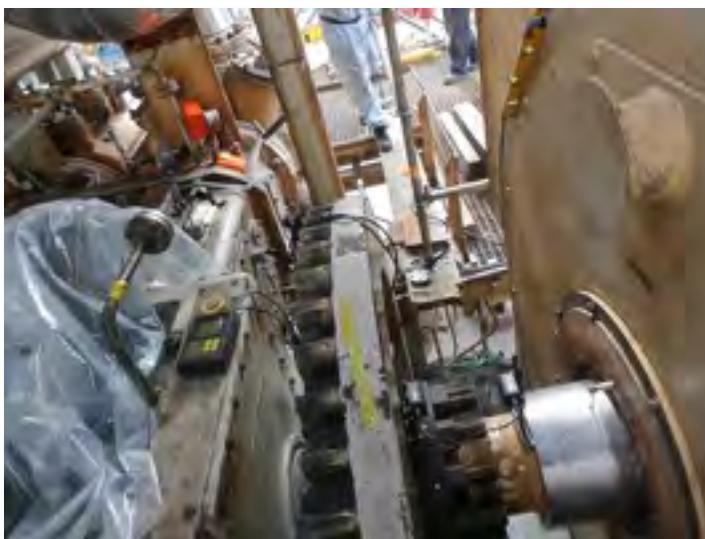
- Firstly measurements of the space between the compressor coupling and the motor where taken with a

dial gauge.

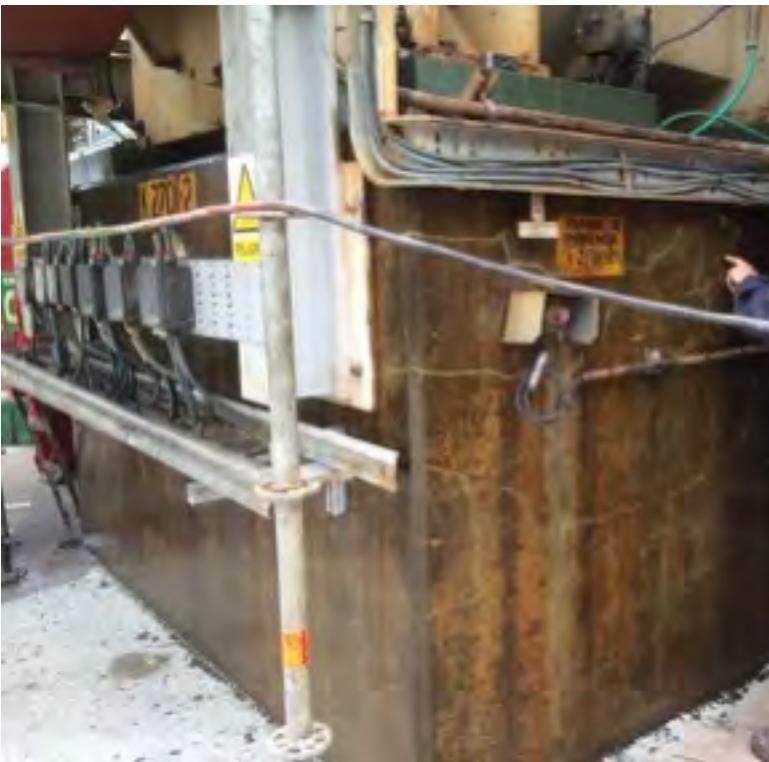
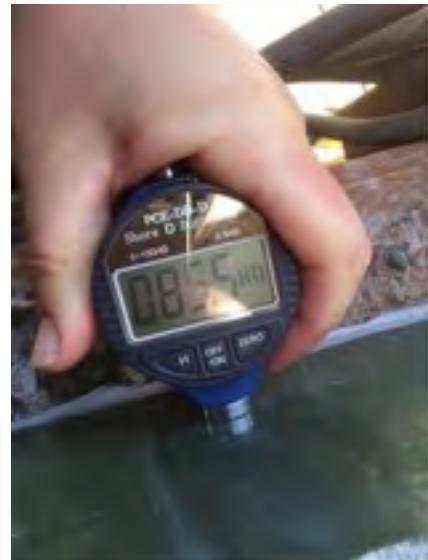
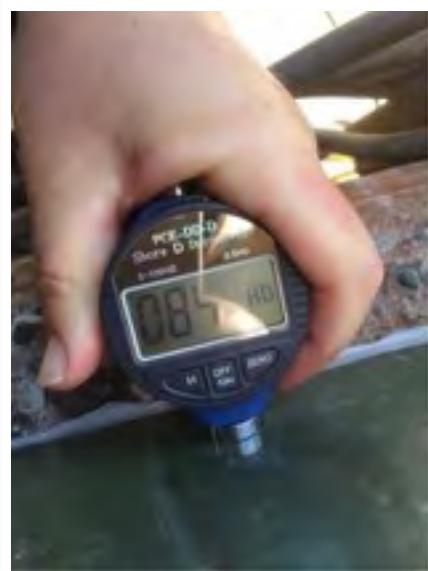
3.12. Before relieving the pressure on the Alphapads, a surface hardness check is necessary to verify to what extent the resin has cured. Approximately, a Shore hardness above 80 guarantees a curing above 90% cured.
