## **Work Report:**

### **Restoring the grout on the footings of the HTF Tanks.**

**Customer:** UTE Andasol 3

**Date:** February 2015

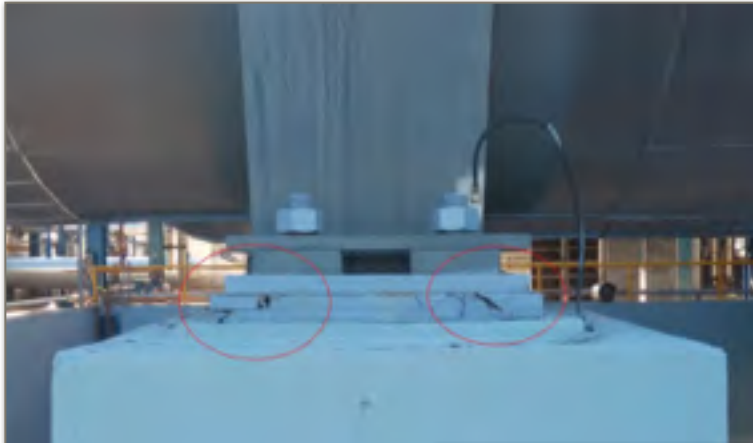
HTF tanks continuously move slightly due to a contraction/dilatation cycle, originated by its temperature changes, along with great changes in the HTF level which combined, exert considerable loads in the footings.

The anchoring+insulation system used for the moving supports is thoroughly deteriorated. The insulation part was designed and built using two different materials: two insulation plates and one cement grout which add up to approximately 110mm in thickness. There are also four M64 anchor bolts per footing, grade unknown, the saddle and the steelplate+friction plates.
